REVEGETATION AND SELECTED TERRAIN DISTURBANCES ALONG  
THE TRANS-ALASKA PIPELINE 1975-1978(U) COLD REGIONS  
RESEARCH AND ENGINEERING LAB HANOVER NH L A JOHNSON  
JUN 81 CRREL-81-12 F/G 6/6

## *Revegetation and selected terrain disturbances along the trans-Alaska pipeline, 1975-1978*

Lawrence A. Johnson

June 1981

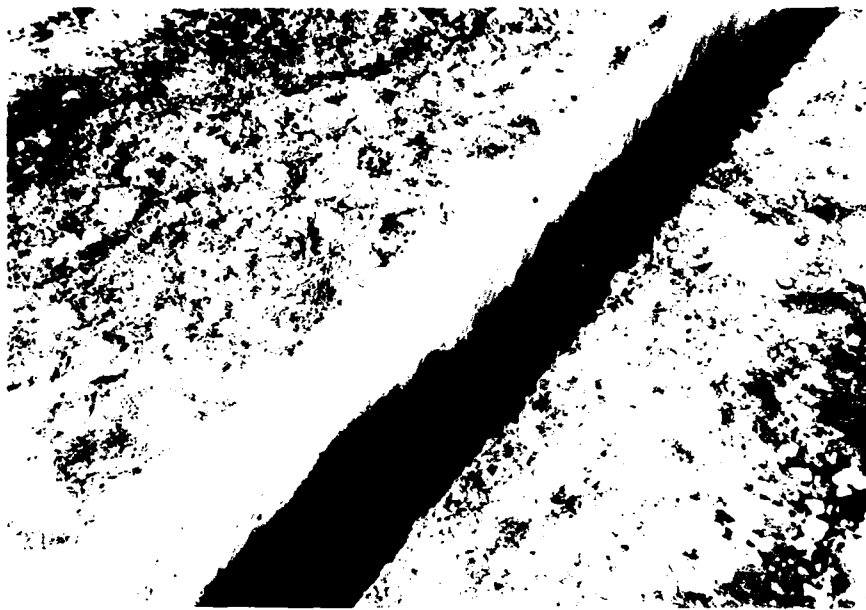
*Figure 32. Close-up of trench excavated with a Roc-Saw. Note spoil over the snowpad.*
